FINAL REPORT SEPTEMBER 2004

REPORT NO. 04-16

44" x 40" METAL PALLET WITH METAL ADAPTERS, CARTRIDGE, 25MM, PA125 METAL BOXES, MIL-STD-1660 FIRST ARTICLE TESTS

U.S. ARMY DEFENSE AMMUNITION CENTER

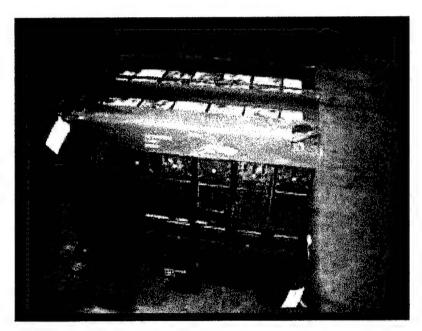
Photo 5. Loaded Test Unit.

A. <u>CONTAINER DATA</u>. The sample test units were inertly loaded to the specified design weight. Special care was taken to ensure that each individual interior ammunition container had the proper amount of weight in order to achieve a realistic pallet center of gravity (CG). Once properly prepared, the test unit was tested using MIL-STD-1660, "Design Criteria for Ammunition Unit Loads," requirements. Photo 5 depicts the test unit loaded.

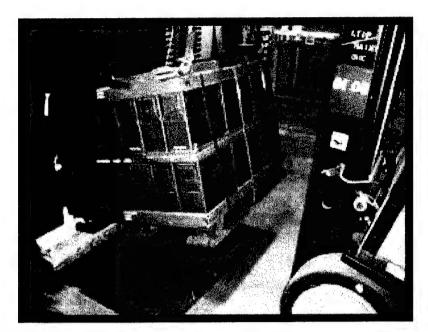
Photo 8. Test Setup for Edgewise Rotational Drop Testing.

3. EDGEWISE ROTATIONAL DROP TEST. Test Unit #1 was edgewise rotationally dropped from a height of 15 inches on both longitudinal sides and both lateral sides. It was noted that a weld had failed on the center brace (DAC Drawing ACV00141) on the intermediate assembly. The damage was deemed to be minor and the testing continued. See Photo 8 for the test setup for the drop tests. Photo 9 shows the failed intermediate assembly weld that was discovered during the disassembly of the test unit.

Photo 9. Weld Failure on Intermediate Assembly.

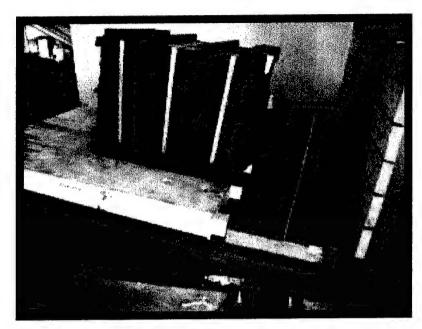
Photo 10. Test Setup for Incline-Impact Testing.

4. <u>INCLINE-IMPACT TEST</u>. Test Unit #1 was incline-impacted on all four sides with the pallet impacting the stationary wall from a distance of 8 feet. No additional problems were encountered. See Photo 10 for test setup for incline-impact testing.

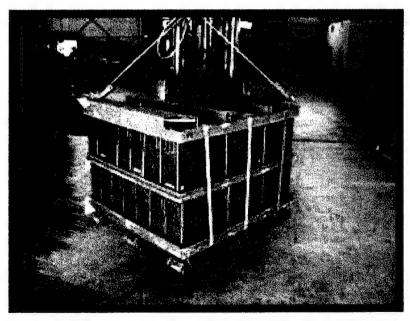
Photo 12. Test Setup for Sling Compatibility Testing.

6. <u>SLING COMPATIBILITY TEST.</u> Test Unit #1 was sling compatibility tested by slinging the container with lifting cables through the lifting rings on the top assembly. No problems were encountered during the lifts. (See Photo 12 for the test setup).

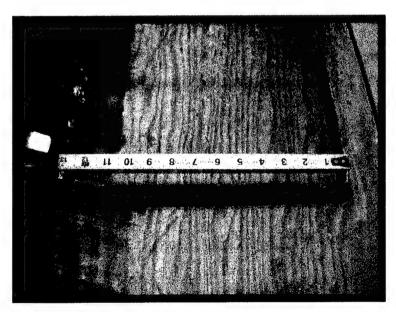
STACKING TEST. While loading Test Unit #5, it was discovered that the intermediate adapter had a stiffener aligned incorrectly and the last box could not be loaded. The dimension should have been 13-7/16" from inside to inside to allow the PA125 box to be positioned. The actual dimension was less than 13". See Photo 14 for a picture of the incorrect intermediate adapter dimension. Corrective action was taken by the manufacturer to rework the adapter and testing was completed satisfactorily. Test Unit #5 was compressed with a load force of 12,825 pounds for 60 minutes on 13 August 2004. No damage was noted as a result of this test.

Photo 14. Intermediate Adapter Wrong Dimension of Test Unit #5.
